**Project Name:** Hydrock Consultants Limited - St Illtyds School - PJ00463464  
**Project Status:** Complete  
**Project Date:** 05/12/2022  
**Lanes Division:** South Wales

As requested, we have recently carried out a drainage CCTV survey at the site location and our full and detailed findings are contained in the attached CCTV report which you can review at your leisure.

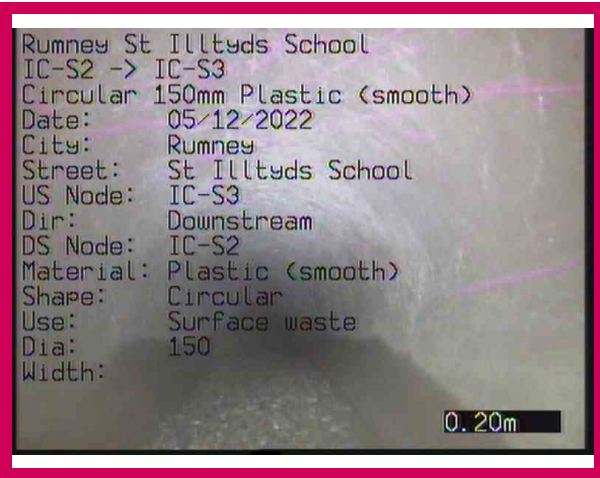
1, 00:00:10, 0.20 m

Settled deposits, coarse, 10% cross-sectional area loss, start

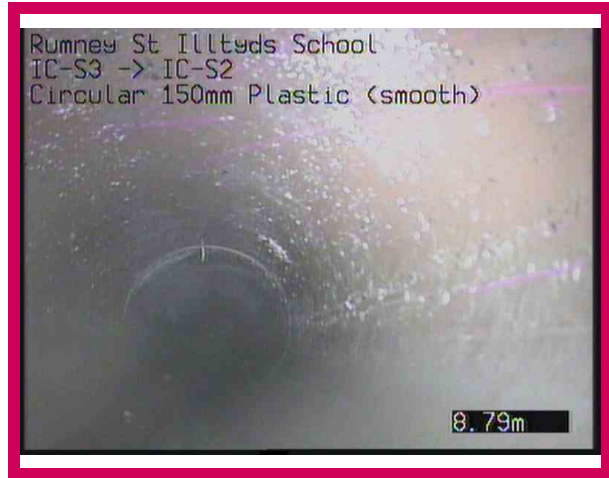
2, 00:01:00, 8.79 m

Settled deposits, coarse, 10% cross-sectional area loss, finish

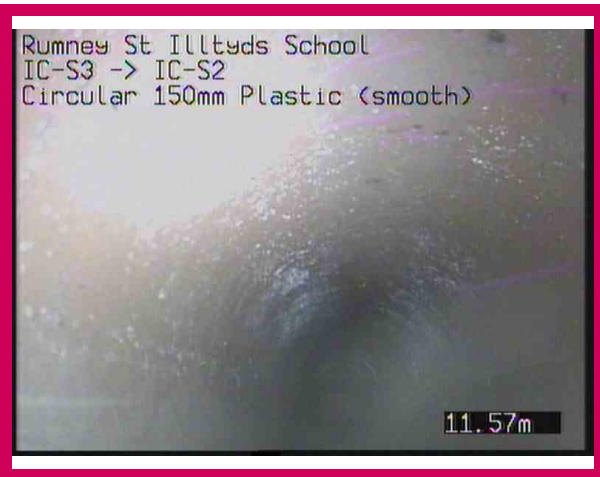
3, 00:01:25, 11.57 m

Settled deposits, coarse, 10% cross-sectional area loss, start

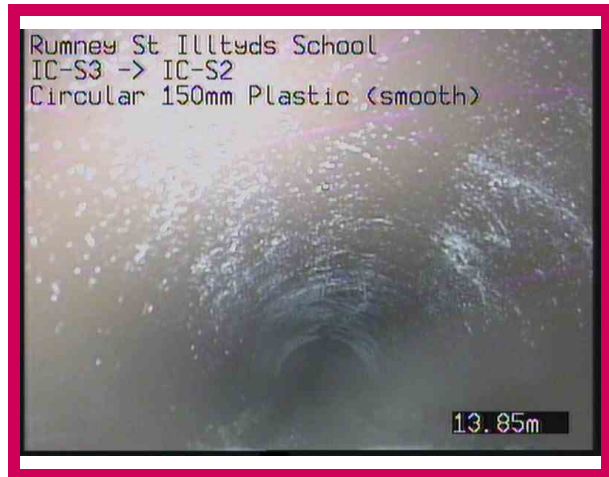
4, 00:01:43, 13.85 m

Settled deposits, coarse, 10% cross-sectional area loss, finish

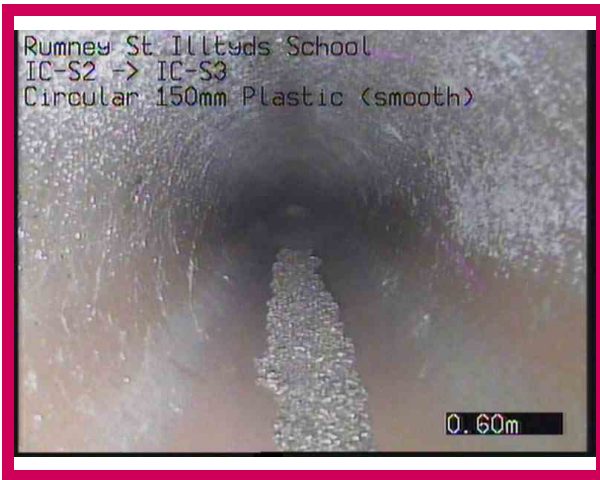
1, 00:00:21, 0.60 m  
 Settled deposits, coarse, 5% cross-sectional area loss, start

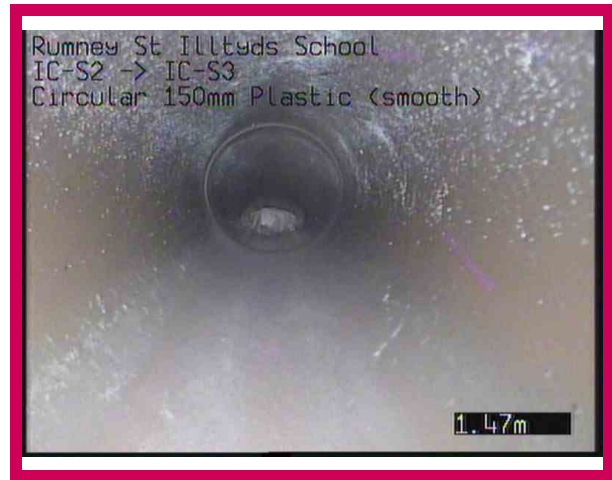
2, 00:00:32, 1.47 m  
 Settled deposits, coarse, 5% cross-sectional area loss, finish

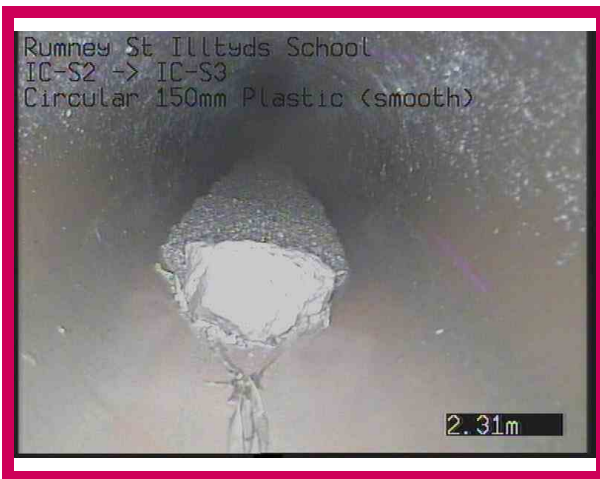
Settled deposits, coarse, 30% cross-sectional area loss, start

3, 00:00:50, 2.31 m  
 Settled deposits, coarse, 30% cross-sectional area loss, start

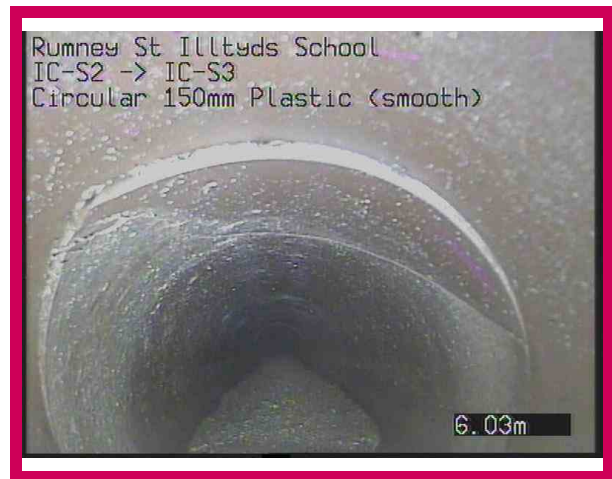
Fracture, circumferential from 9 o'clock to 3 o'clock

4, 00:02:04, 6.03 m  
 Fracture, circumferential from 9 o'clock to 3 o'clock

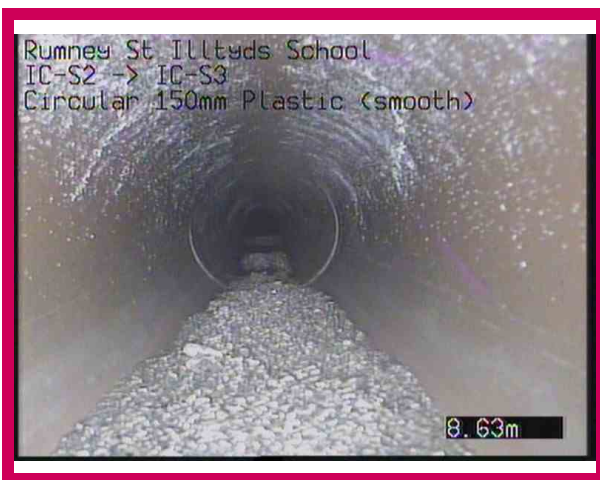
Settled deposits, coarse, 30% cross-sectional area loss, finish

5, 00:03:55, 8.63 m  
 Settled deposits, coarse, 30% cross-sectional area loss, finish

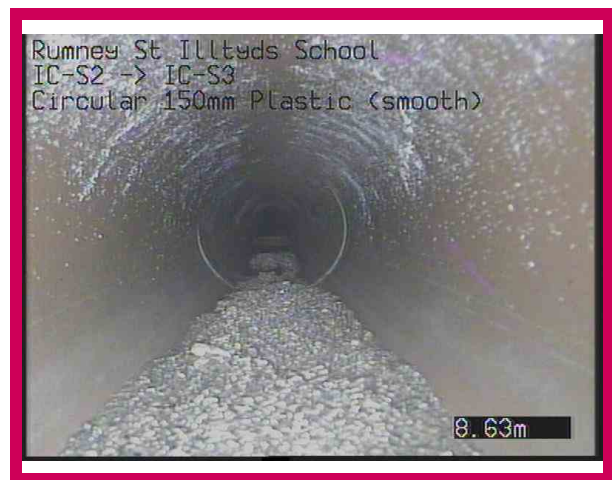
6, 00:03:55, 8.63 m  
 Survey abandoned, Crawler unable to push debris any further

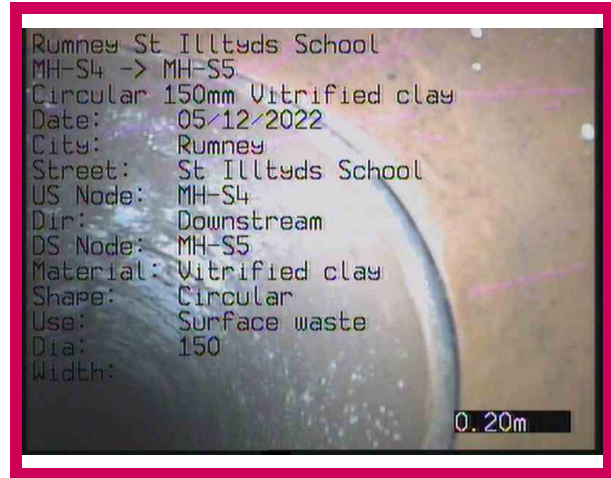
2, 00:00:09, 0.20 m  
Line deviates left

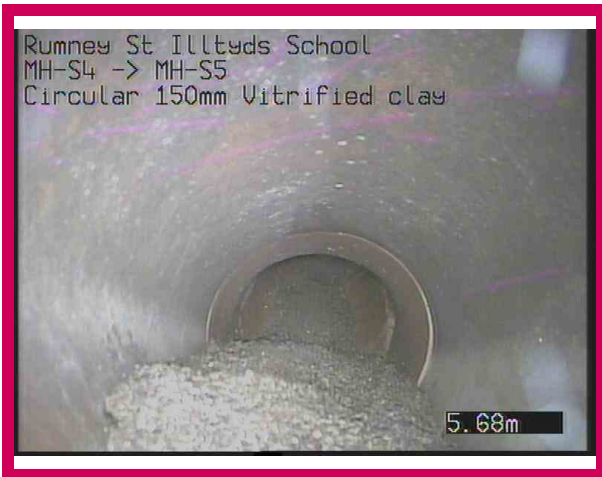
Settled deposits, coarse, 35% cross-sectional area loss

3, 00:00:37, 5.68 m  
Settled deposits, coarse, 35% cross-sectional area loss

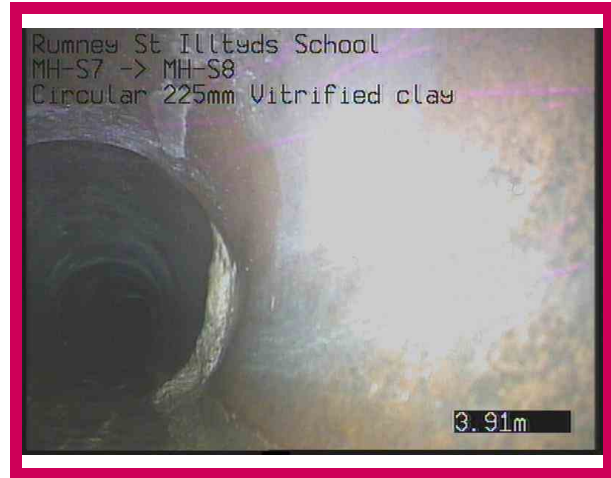
2, 00:00:42, 3.91 m  
Attached deposits, encrustation at joint from 2 o'clock to 10 o'clock, 5% cross-sectional area loss

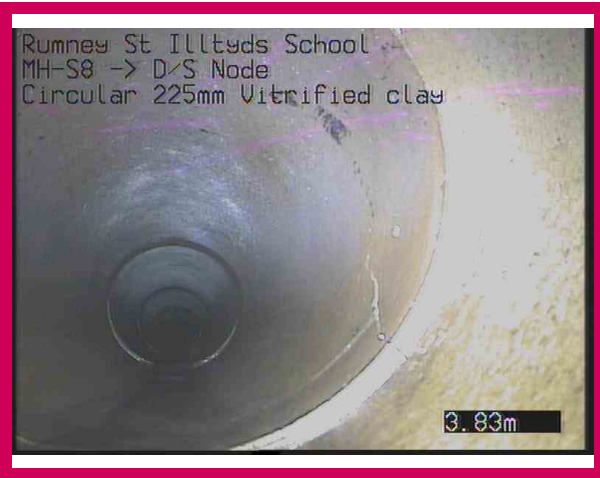
Fracture, circumferential at joint from 2 o'clock to 5 o'clock

1, 00:00:46, 3.83 m  
 Fracture, circumferential at joint from 2 o'clock to 5 o'clock

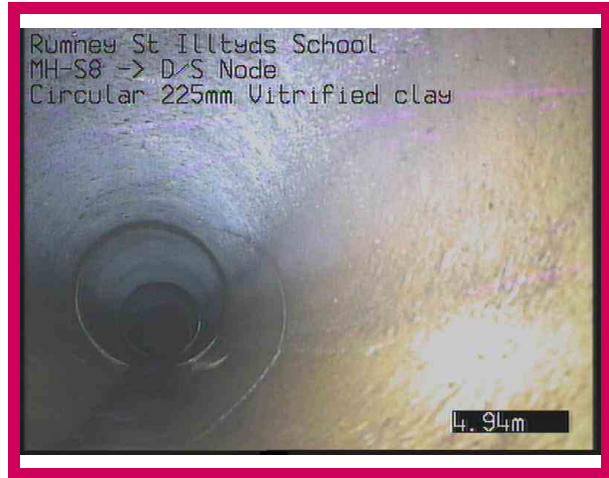
Fracture spiral from 2 o'clock to 6 o'clock

2, 00:01:00, 4.94 m  
 Fracture spiral from 2 o'clock to 6 o'clock

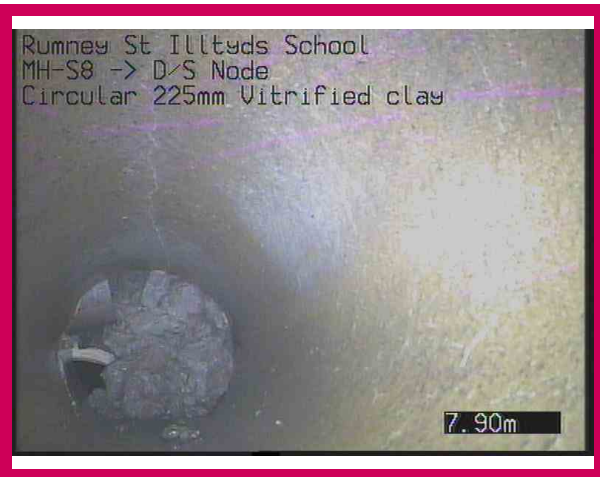
Fracture, multiple from 12 o'clock to 12 o'clock

3, 00:01:23, 7.90 m  
 Fracture, multiple from 12 o'clock to 12 o'clock

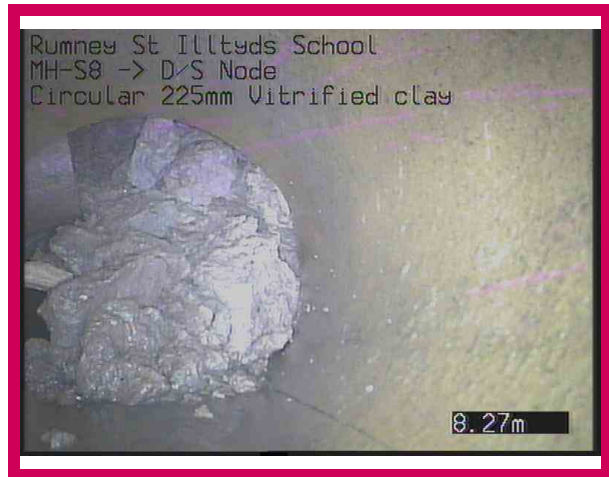
Collapsed drain or sewer

4, 00:01:35, 8.27 m  
 Collapsed drain or sewer

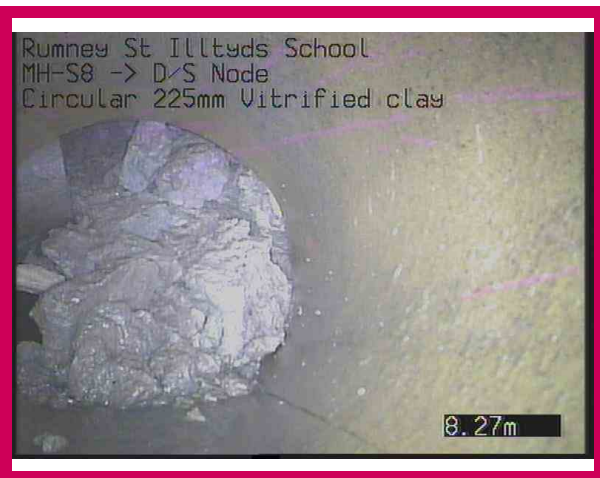
5, 00:01:37, 8.27 m  
 Survey abandoned, Camera unable to pass collapsed pipework
