Phase 2 Interpretative Ground Investigation Report

Project name	Cardiff Sufficiency Schemes '22 – St Illtyds		
Document title	Phase 2 Interpretative Ground Investigation Report - Additional Geo Works Option B		
Document reference	20700-HYD-XX-04-RP-GE-1002		
Author	Daniel Kaye BSc (Hons) MSc FGS		
Revision	First Issue		
Date	31 January 2023	Approved	✓

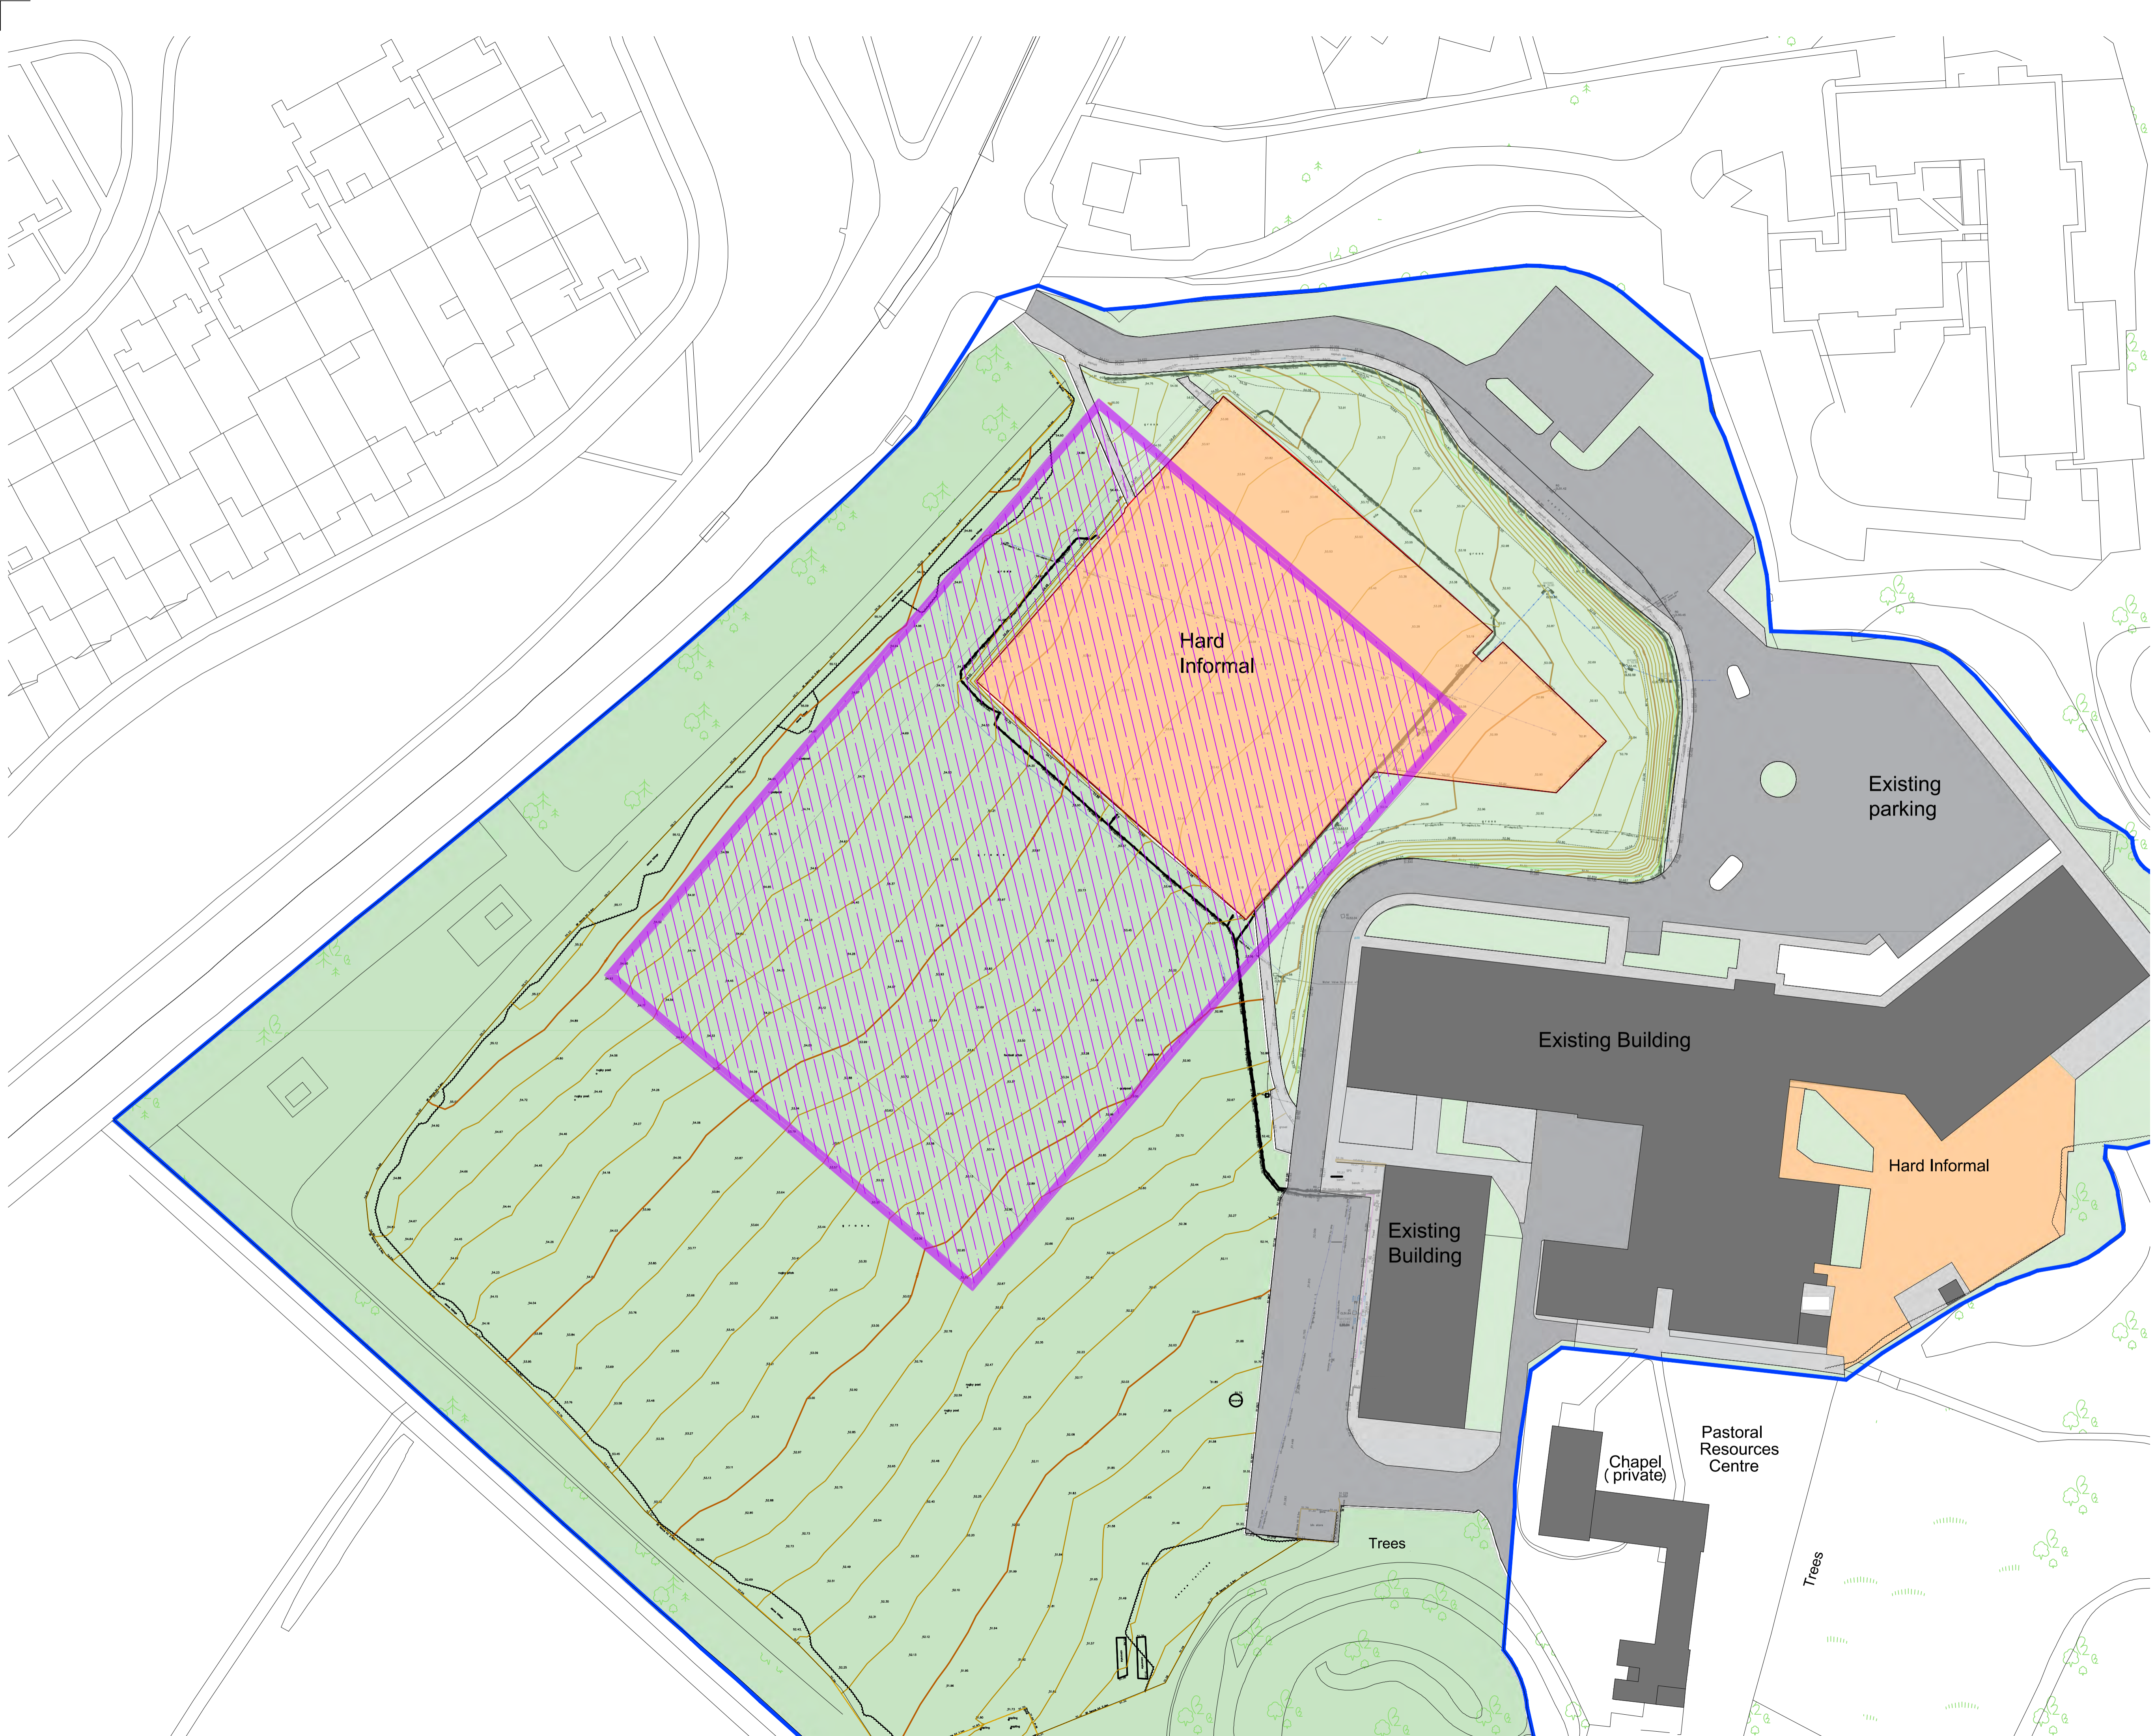
DRAWING NO. (PROJECT CODE-ORIGINATOR-ZONE-LEVEL-TYPE-ROLE-NUMBER) 20700-HYD-XX-04-DR-GE-1003 REVISION P2

- Key**
- Boundary line
 - Site Ownership Boundary line
 - Proposed Pitch
 - Trees
 - Existing Building

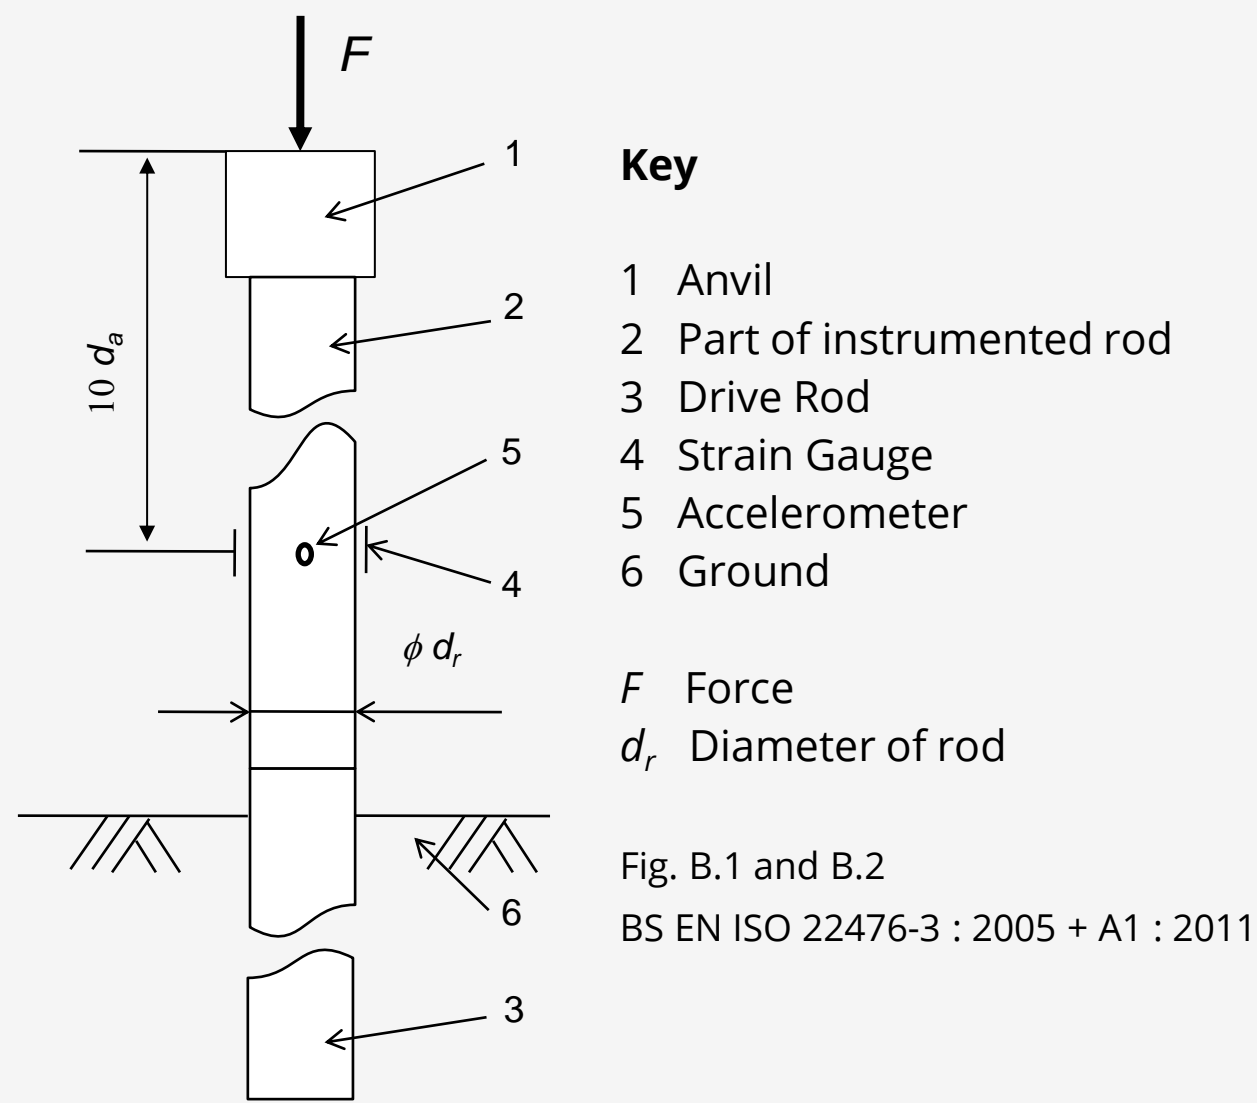
Characteristics of the instrumented rod

Diameter: $d_r = 0.052\text{ m}$
 Length of instrumented rod: 0.558 m
 Area: $A = 11.61\text{ cm}^2$
 Modulus: $E_a = 206843\text{ MPa}$

$E_{\text{meas}} = 0.350\text{ kN-m}$

$$\text{Energy Ratio (Er)} = \frac{E_{\text{meas}}}{E_{\text{theor}}}$$

74.01%
 © COPYRIGHT 2022

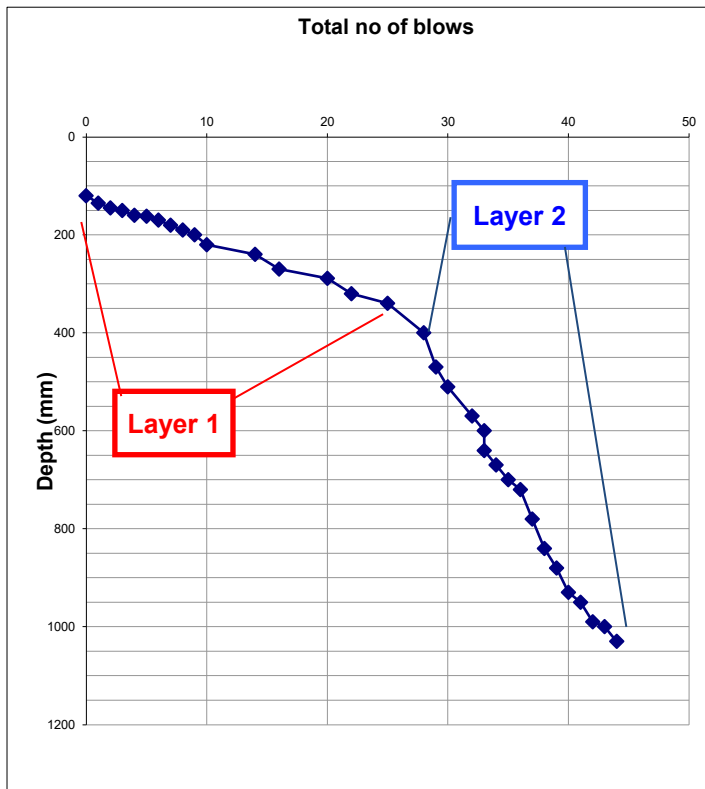
Total No. of Blows	Equip Depth Rdg (mm)	Total depth (mm)	Penetration per blow (mm)	Layer	Top of layer (mm)	Base of layer (mm)	Blows at top of layer	Blows at base of layer	Mean penetration per blow (mm)	CBR of layer (%)
0	190	120	0	Layer 1	120	340	0	25	8.8	30
1	205	135	15.00							
2	215	145	10.00							
3	220	150	5.00							
4	230	160	10.00	Layer 2	340	1030	25	44	36.3	6.8
5	232	162	2.00							
6	240	170	8.00							
7	250	180	10.00							
8	260	190	10.00	Overall Mean	120	1030	0	44	20.7	12
9	270	200	10.00							
10	290	220	20.00							
14	310	240	5.00							
16	340	270	15.00							
20	359	289	4.75							
22	390	320	15.50							
25	410	340	6.67							
28	470	400	20.00							
29	540	470	70.00							
30	580	510	40.00							
32	640	570	30.00							
33	670	600	30.00							
33	710	640	40.00							
34	740	670	30.00							
35	770	700	30.00							
36	790	720	20.00							
37	850	780	60.00							
38	910	840	60.00							
39	950	880	40.00

40	1000	930	50.00							
41	1020	950	20.00							
42	1060	990	40.00							
43	1070	1000	10.00							
44	1100	1030	30.00

Particles >20mm	Yes	Sheet 3 of 6
Operators	CF/MC

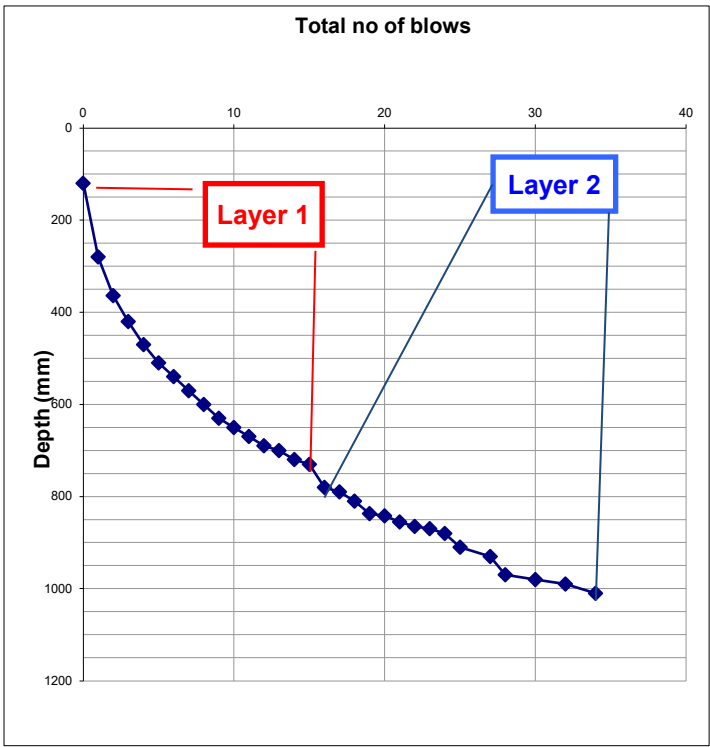
DYNAMIC CONE PENETRATION TEST RESULTS				Date	21.11.2022	CJAssociates				
Client Name		Hydrock		Report Ref.	2072123	Commencing depth				
Job Name		St Illyds		Zero Readings -		Initial	120			
Where commenced:		Base of inspection pit		Hard standing		Settled	120			
eg existing level, core hole etc				Test No.	3					
Test location:		DCP3		Marker:						
Material description:		Clay								
Total No. of Blows	Equip Depth Rdg (mm)	Total depth (mm)	Penetration per blow (mm)	Layer	Top of layer (mm)	Base of layer (mm)	Blows at top of layer	Blows at base of layer	Mean penetration per blow (mm)	CBR of layer (%)
0	180	120	0	Layer 1	120	730	0	15	40.7	6
1	340	280	160.00							
2	424	364	84.00							
3	480	420	56.00	Layer 2	730	1010	15	34	14.7	17.6
4	530	470	50.00							
5	570	510	40.00							
6	600	540	30.00	Overall Mean	120	1010	0	34	26.2	10
7	630	570	30.00							
8	660	600	30.00							
9	690	630	30.00							
10	710	650	20.00

11	730	670	20.00							
12	750	690	20.00							
13	760	700	10.00							
14	780	720	20.00							
15	790	730	10.00							
16	840	780	50.00							
17	850	790	10.00							
18	870	810	20.00							
19	897	837	27.00							
20	902	842	5.00							
21	915	855	13.00							
22	925	865	10.00							
23	930	870	5.00							
24	940	880	10.00							
25	970	910	30.00							
27	990	930	10.00							
28	1030	970	40.00							
30	1040	980	5.00							
32	1050	990	5.00							
34	1070	1010	10.00							
Remarks:		Refused on obstruction								
Particles >20mm	Yes									
Operators	CF/MC
