Cardiff Sufficiency Schemes '22- St Illtyds

Phase 2 Ground Investigation Report

Doc ref: 20700-HYD-XX-04-RP-GE-1001

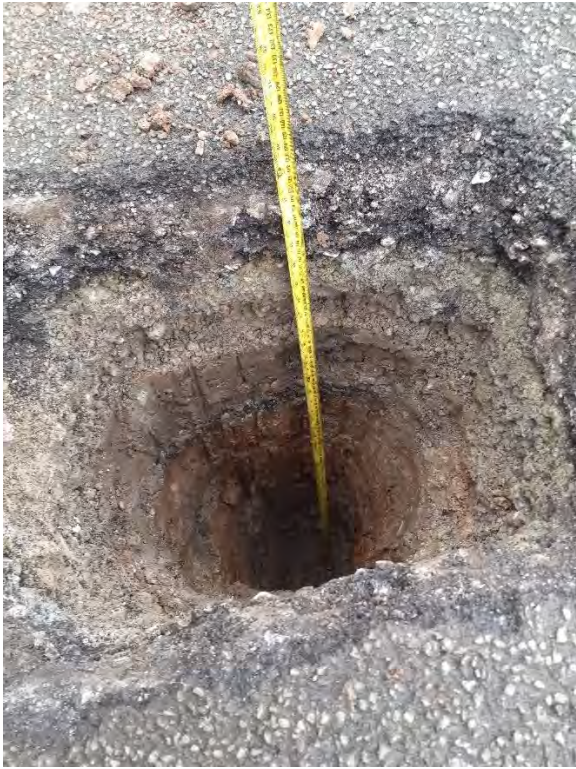
Site Investigation Photograph 7
Date: 21/02/22
Direction Photograph Taken: n/a.
Description: Starter pit for BH01.

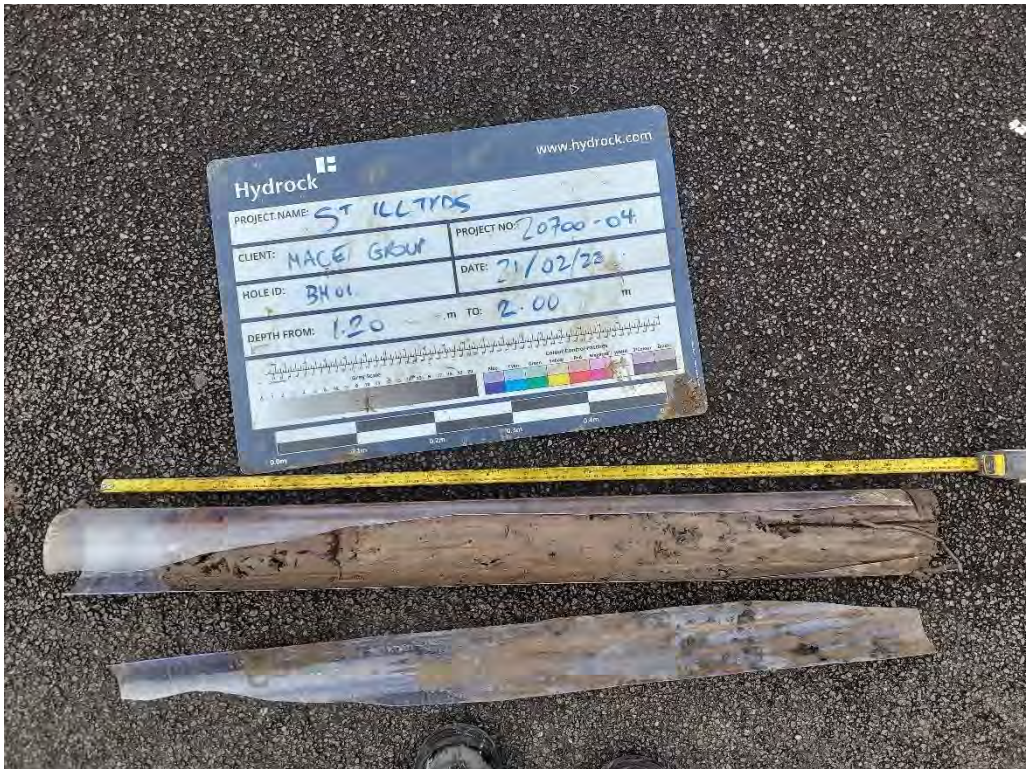
Site Investigation Photograph 8
Date: 21/02/22
Direction Photograph Taken: n/a.
Description: Core from BH01 (1.20-2.00m bgl).

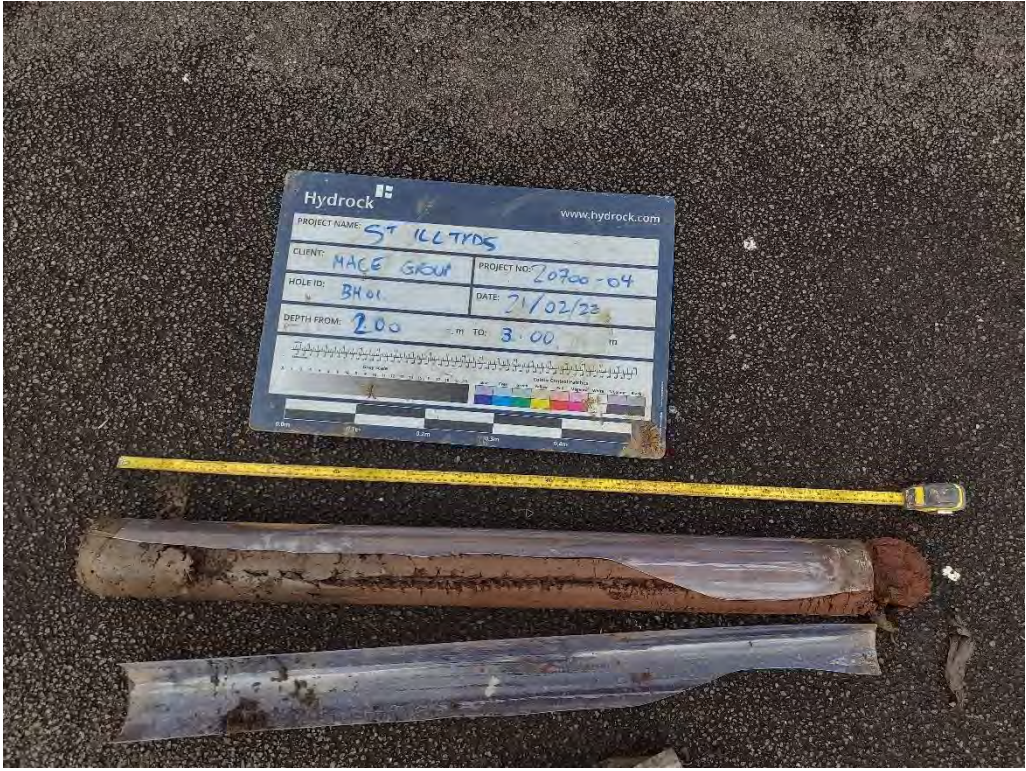
Site Investigation Photograph 9
Date: 21/02/22
Direction Photograph Taken: n/a.
Description: Core from BH01 (2.00-3.00m bgl).

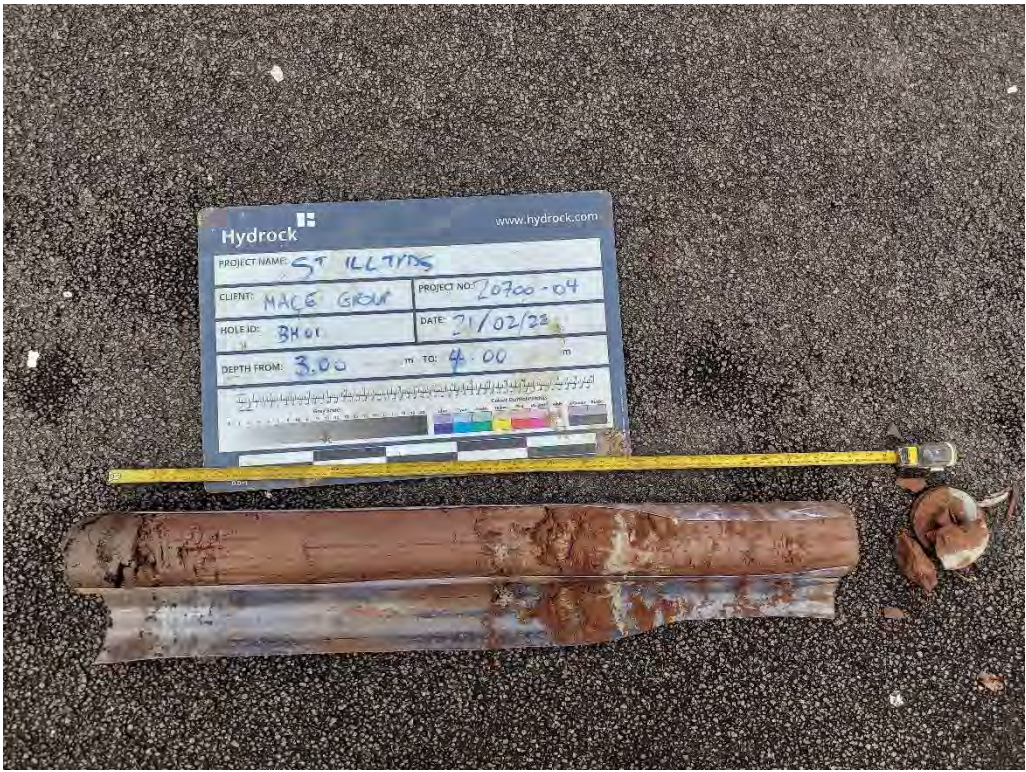
Site Investigation Photograph 10
Date: 21/02/22
Direction Photograph Taken: n/a.
Description: Core from BH01 (3.00-4.00m bgl).

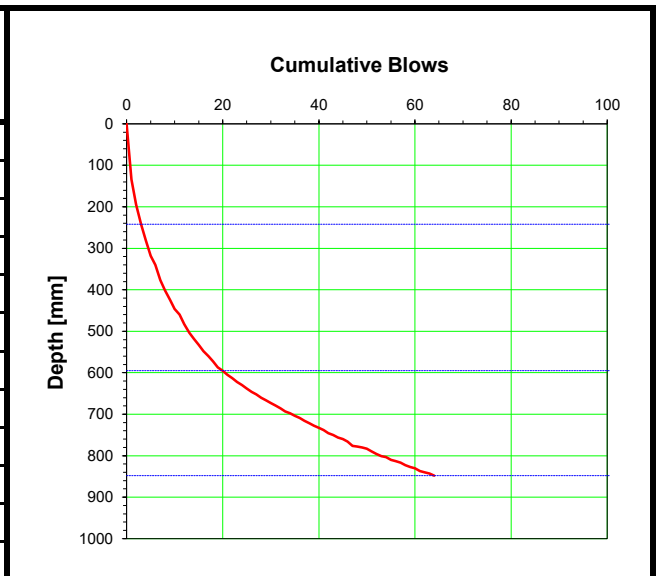
Test Location: TRL-DCP-01

Layer	No of Blows	Cumulative Blows	CBR [%]	Layer Thickness [mm]	Total Depth [mm]
Layer 1	3	3	3	242	242
Layer 2	17	20	12	353	595
Layer 3	44	64	48	253	848

Comments: TRL Equation : $\text{Log}_{10}(\text{CBR}) = 2.480 - 1.057 \times \text{Log}_{10}(\text{Strength})$

The subgrade stiffness (CBR) results are summarised in Table 5.5 and the plots are presented in Appendix C. CBR testing was undertaken in the proposed sports pitch area. As it is recommended that topsoil be removed prior to construction of the 3G pitch, the CBR ranges quoted in the table below relate to the top of the Raglan Mudstone Formation. "Layer 1" as marked in the plots in Appendix C represents topsoil and can therefore be discounted.
