**Project Name:** Hydrock Consultants Limited - St Illtyds School - PJ00463464  
**Project Status:** Complete  
**Project Date:** 05/12/2022  
**Lanes Division:** South Wales

As requested, we have recently carried out a drainage CCTV survey at the site location and our full and detailed findings are contained in the attached CCTV report which you can review at your leisure.

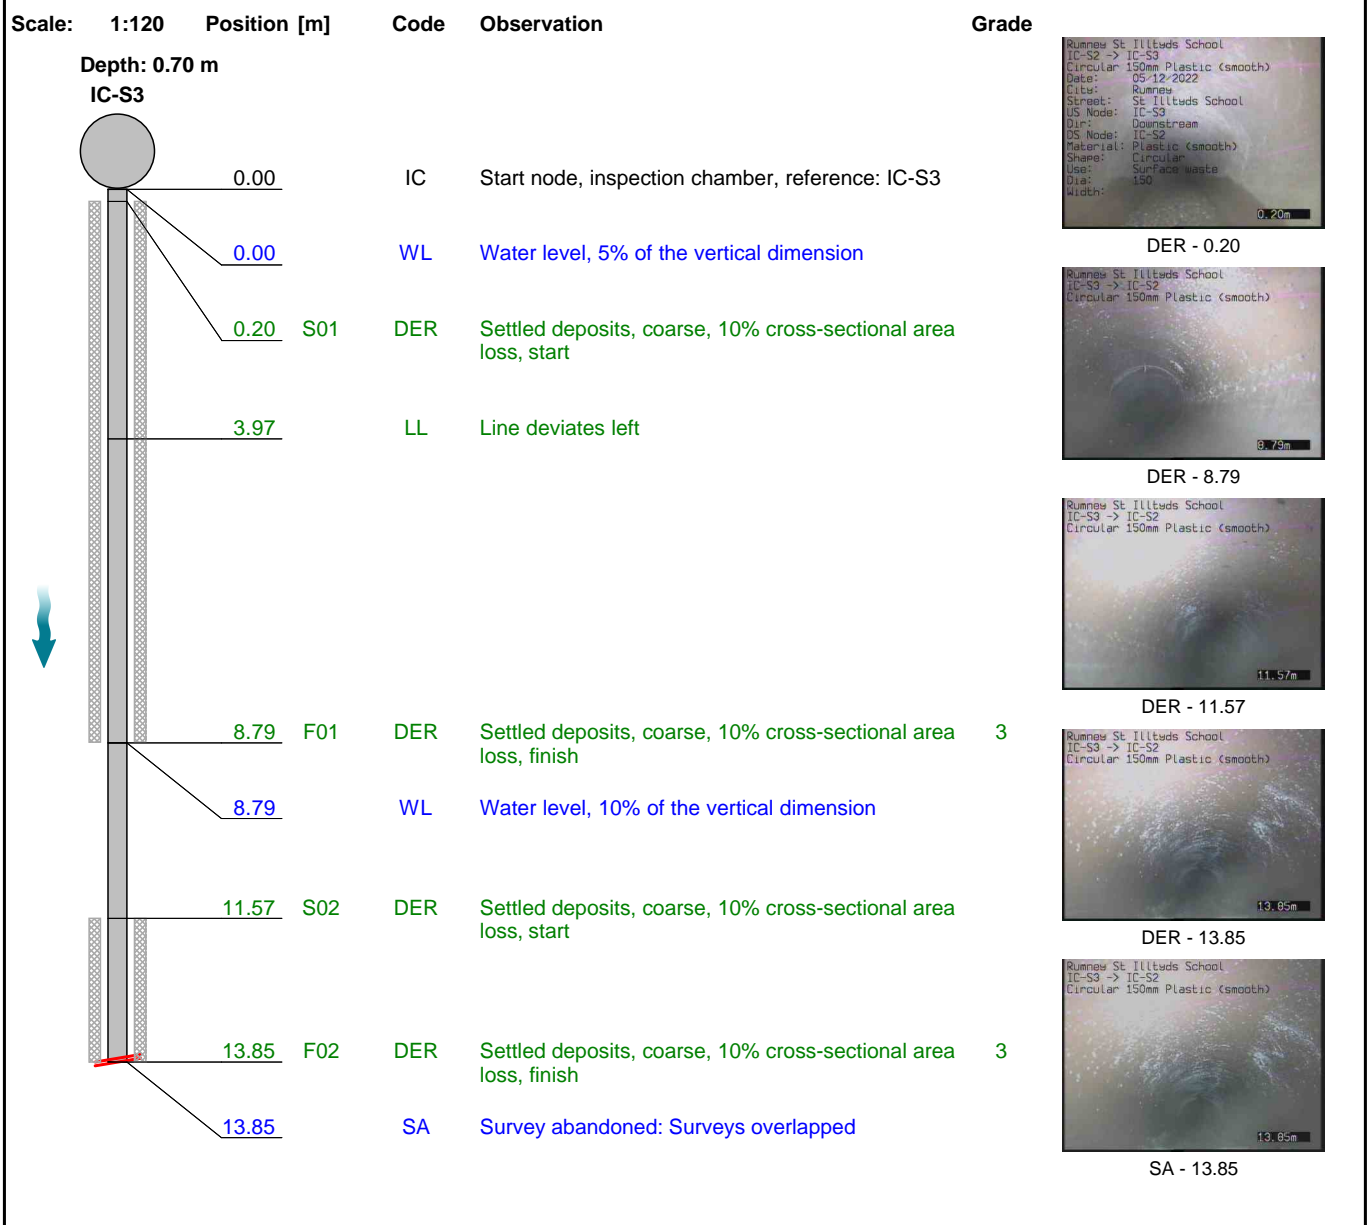
Construction Features					Miscellaneous Features				
Structural Defects					Service & Operational Observations				
STR No. Def	STR Peak	STR Mean	STR Total	STR Grade	SER No. Def	SER Peak	SER Mean	SER Total	SER Grade
0	0.0	0.0	0.0	1.0	2	2.0	1.7	24.0	3.0

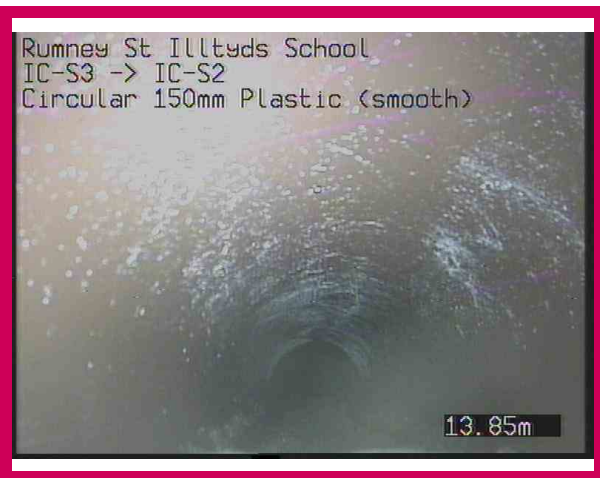
5, 00:01:44, 13.85 m

Survey abandoned, Surveys overlapped

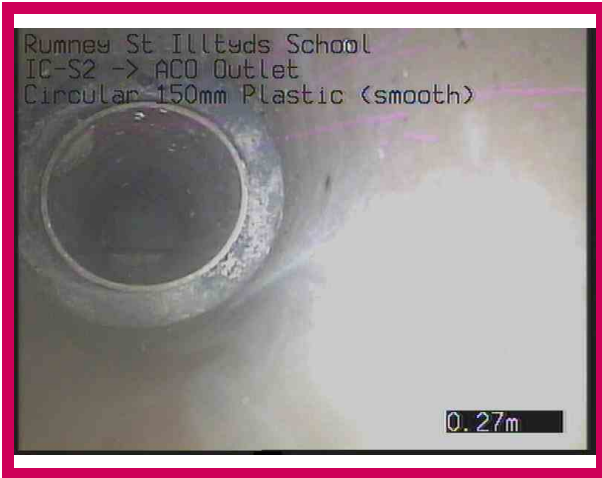
1, 00:00:20, 0.27 m  
Size changes, new size(s), 100mm high

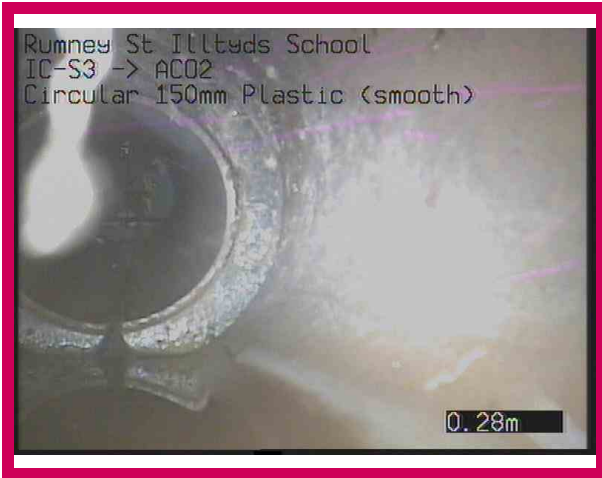
1, 00:00:20, 0.28 m  
Size changes, new size(s), 100mm high

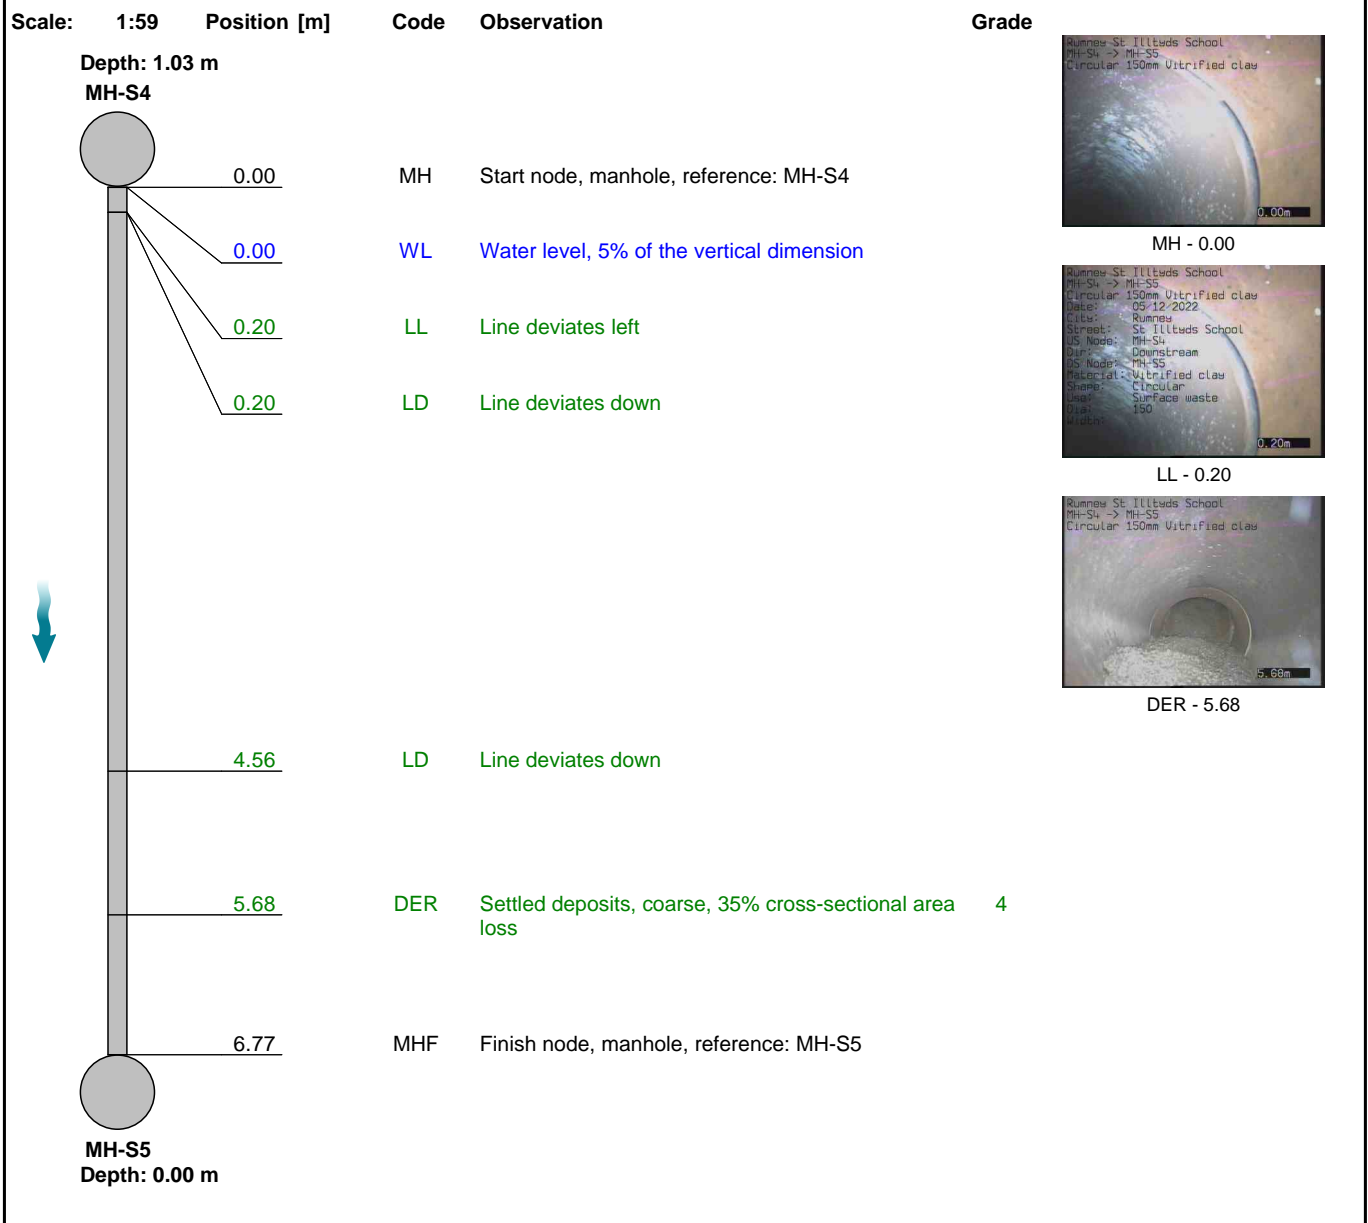
Construction Features					Miscellaneous Features				
Structural Defects					Service & Operational Observations				
STR No. Def	STR Peak	STR Mean	STR Total	STR Grade	SER No. Def	SER Peak	SER Mean	SER Total	SER Grade
0	0.0	0.0	0.0	1.0	1	5.0	0.7	5.0	4.0

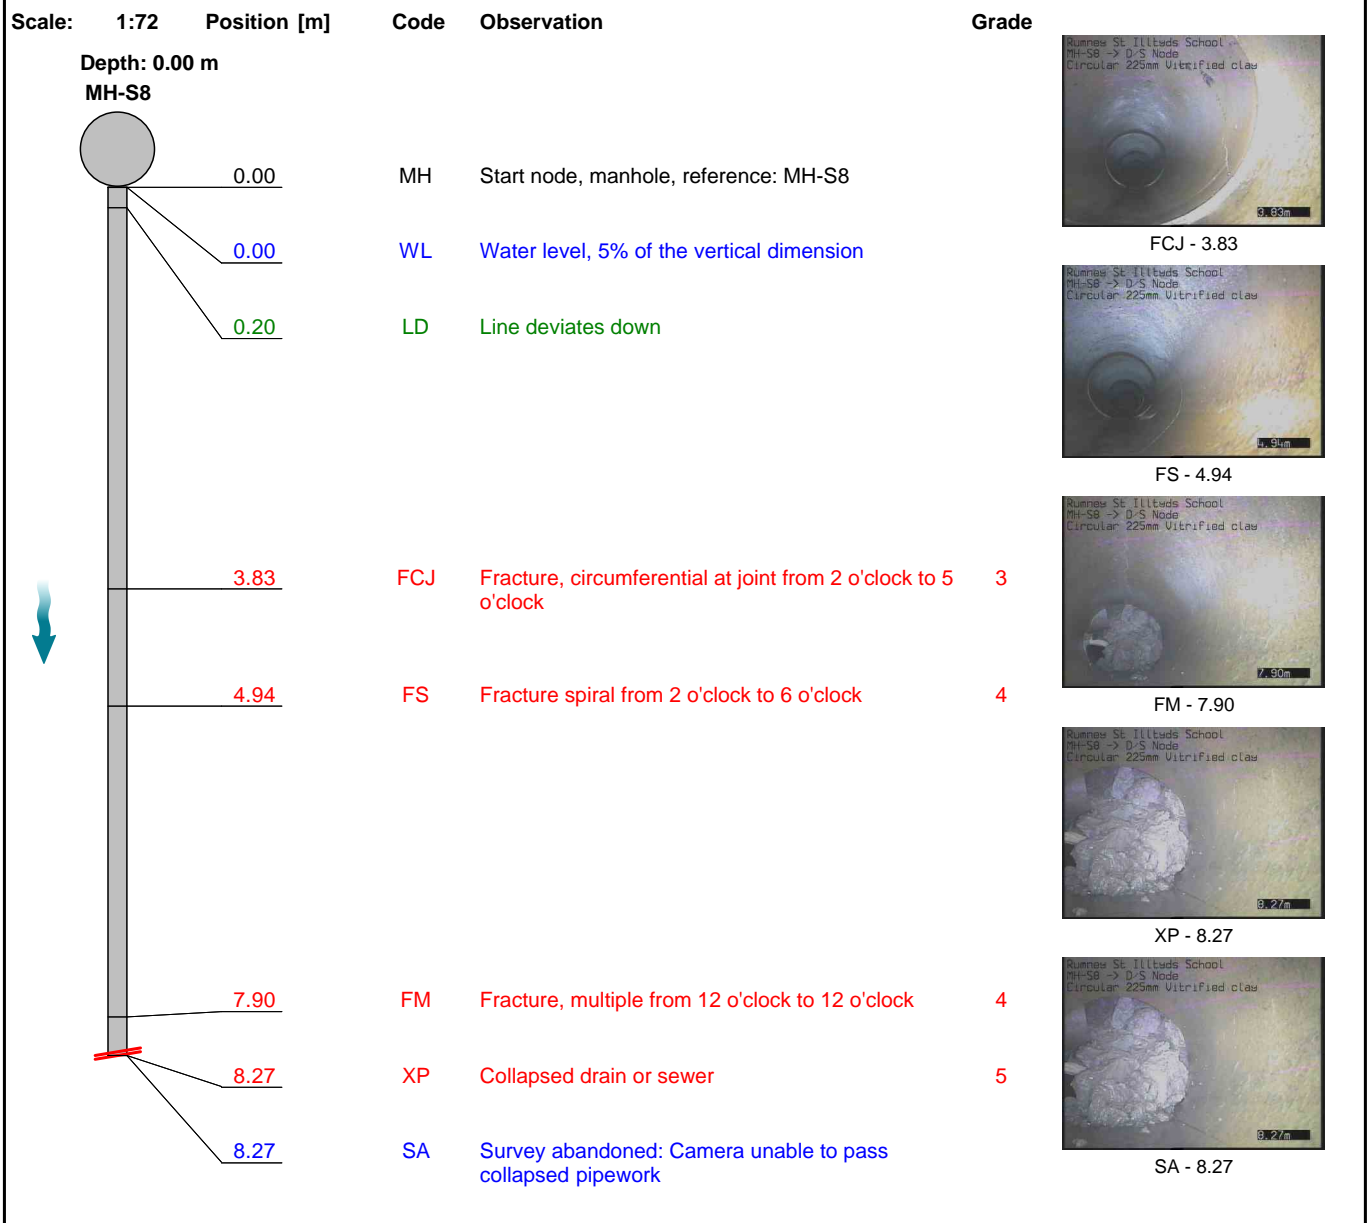
Collapsed drain or sewer

Construction Features					Miscellaneous Features				
Structural Defects					Service & Operational Observations				
STR No. Def	STR Peak	STR Mean	STR Total	STR Grade	SER No. Def	SER Peak	SER Mean	SER Total	SER Grade
4	165.0	44.1	365.0	5.0	0	0.0	0.0	0.0	1.0

We have identified the need for further works and will provide a quotation which will highlight the areas of concern, the most appropriate remedial technique and all associated costings.
